Texas Commission on Environmental Quality
Investigation Report
MCC RECYCLING LLP
CN603445016

Investigation # 768045

Investigation Type : Compliance Investigation

Location : 200 N RICHEY ST., PASADENA,
TX 77506

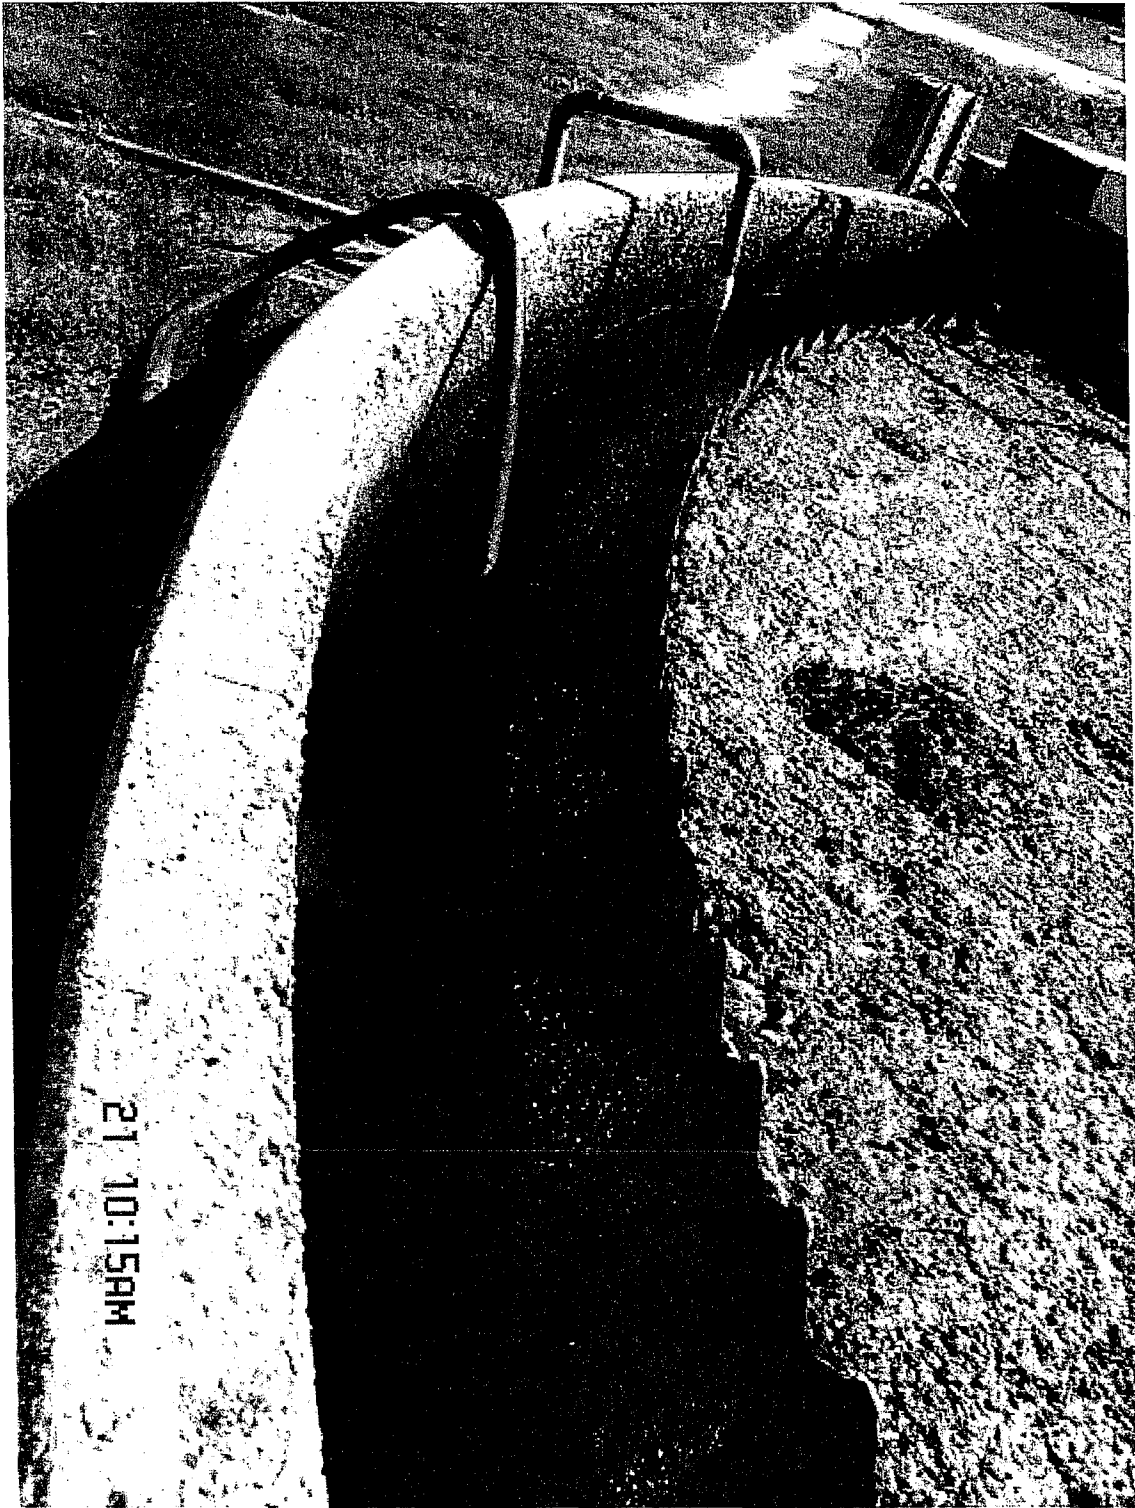
19. This is a picture of the clarifier flume in the vessel being used by MCC Recycling as the final clarifier. Note the water in the flume and the hose. Also note the floating solids inside the weir. The date in the corner of the picture is incorrect. The picture was taken on August 20, 2009.

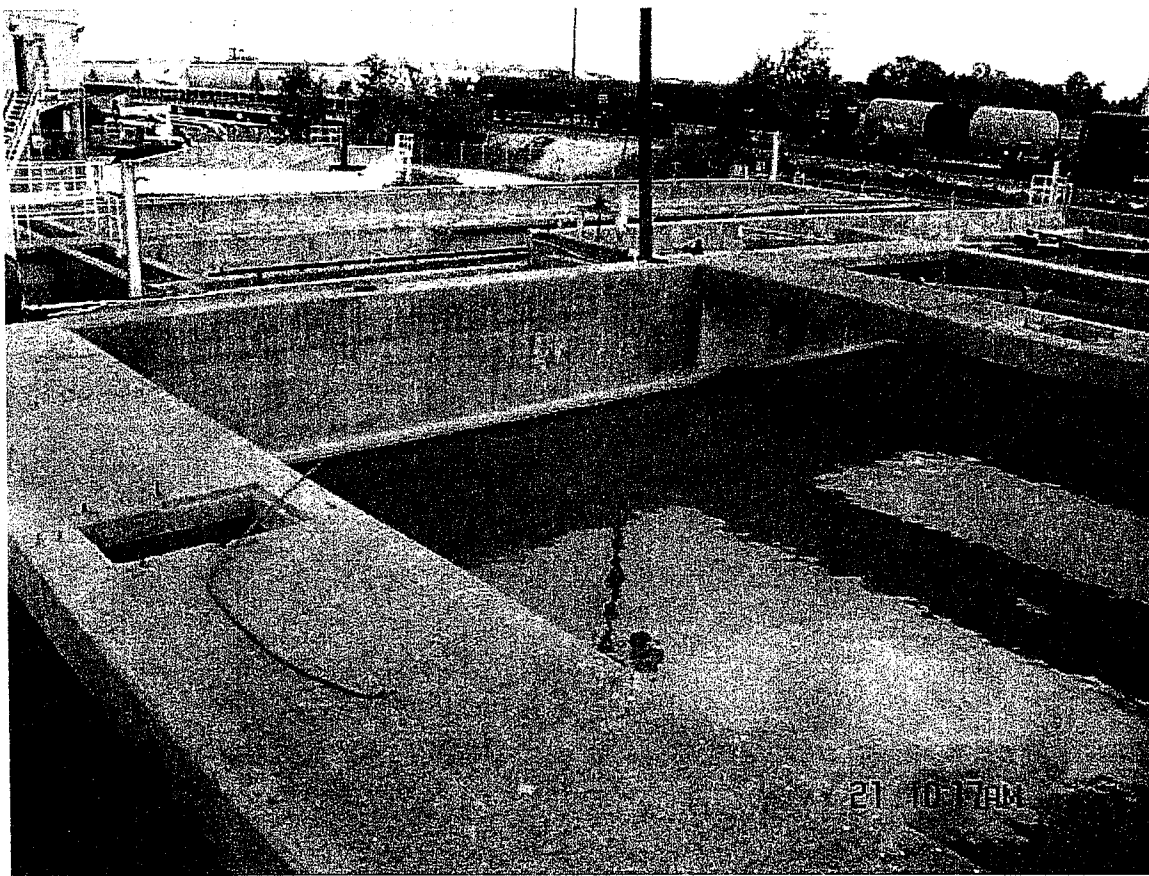
20. This is a picture of the old aeration basin at the MCC Recycling east plant. Note the brownish color of the water. This had not gone septic. The date in the corner of this picture is incorrect. The picture was taken on august 20, 2009.

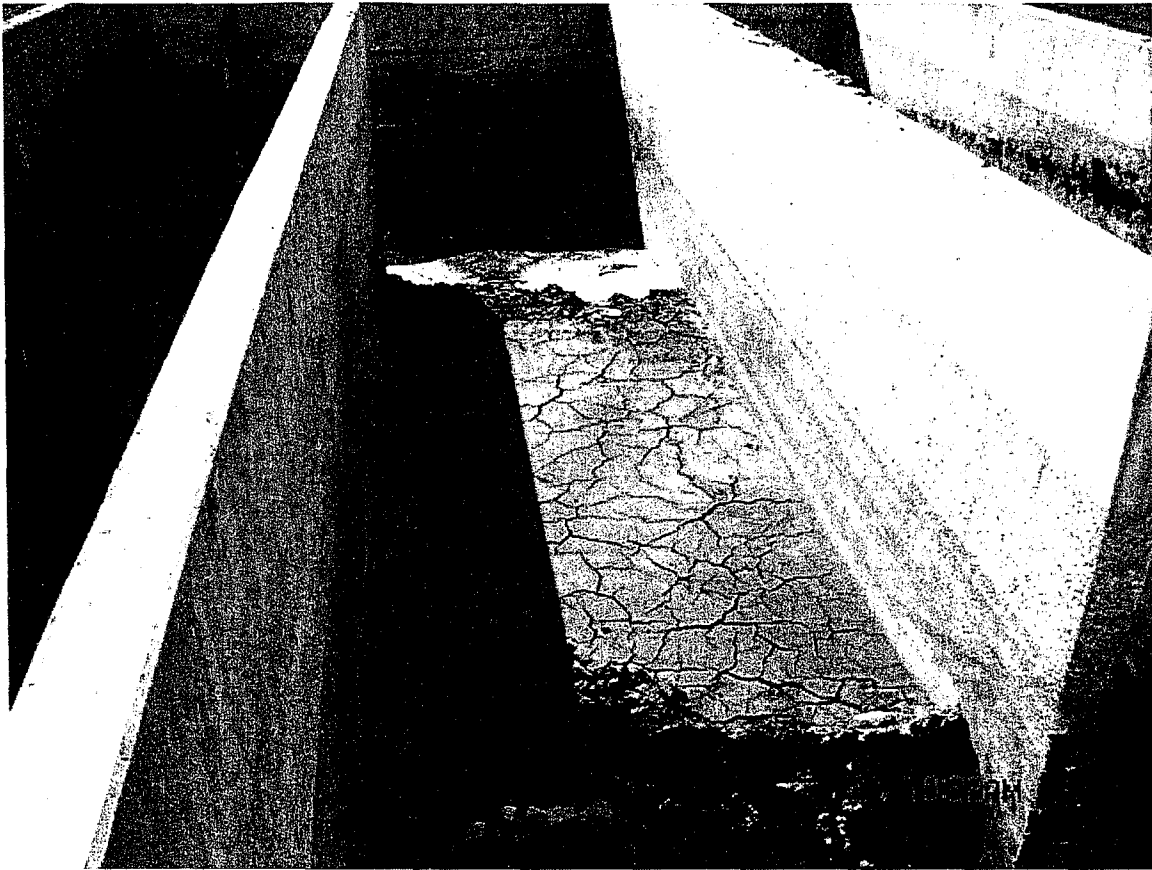
There was still some sludge being stored in the old chlorine contact chamber. The injunction required that all of the sludge was to have been removed from the chlorine contact chamber within 60 days. The injunction was issued June 8, 2009. Sixty days passed on August 7, 2009. (see attached pictures numbers 22 and 23)

22. This is a picture of some of the remaining sludge in the old chlorine contact chamber at the MCC Recycling east plant. The date in the picture is incorrect. The picture was taken on August 20, 2009.

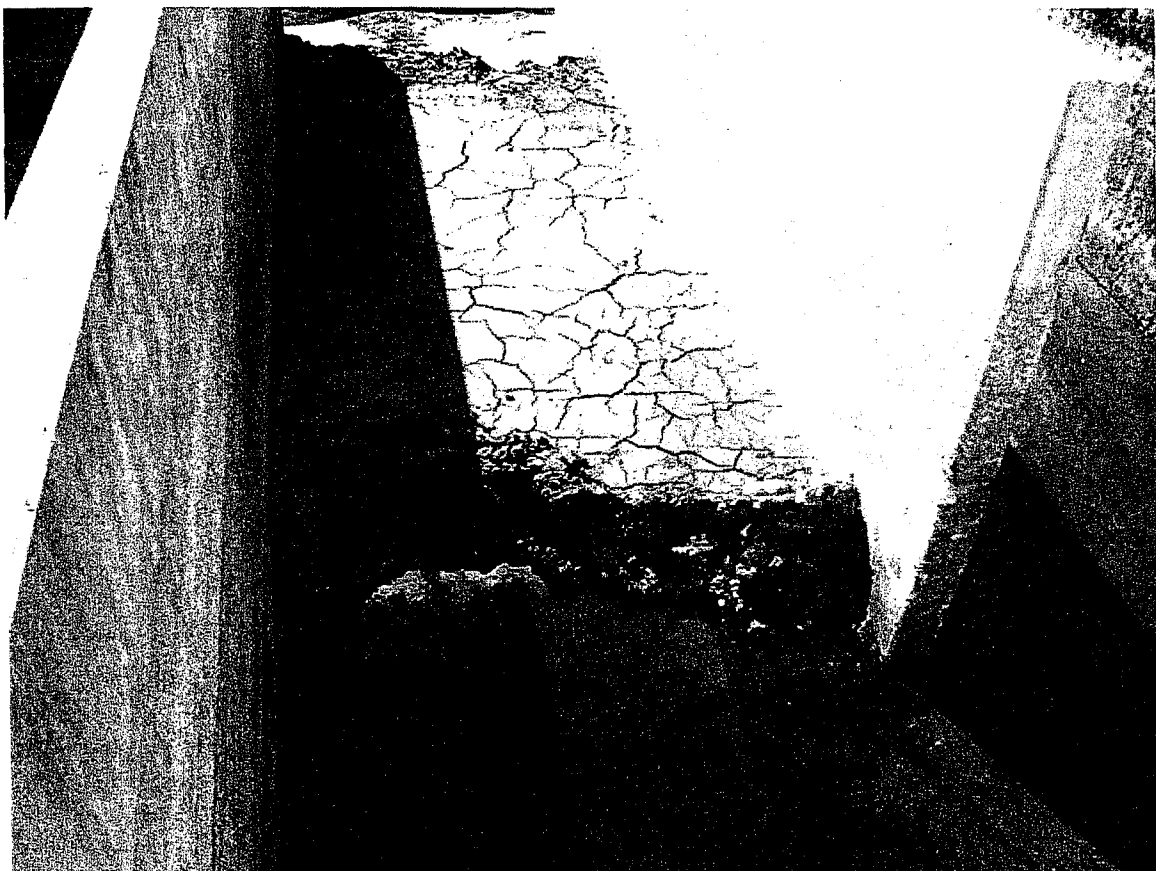
23. This is another picture of the remaining sludge in the old chlorine contact chamber. The chamber is located at the MCC Recycling facility east plant. The date in the corner of the picture is incorrect. The actual date was August 20, 2009.

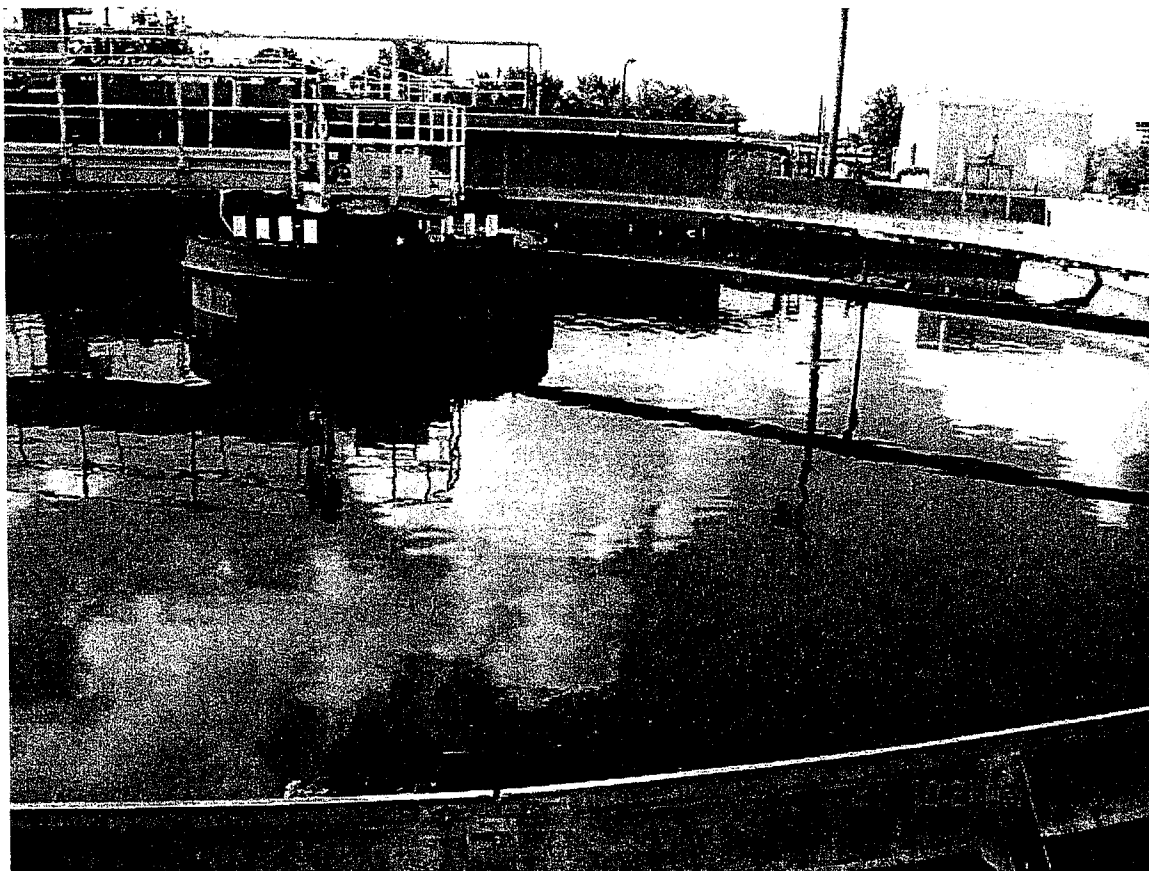
25. View of one of the old final clarifiers at the MCC Recycling east plant. Note the color of the wastewater in the clarifier. The water is black indicating that the wastewater is turning anaerobic (septic). There were septic odors, but they were not very strong at the time. The date in the corner of the picture is incorrect. The actual date was August 20, 2009.

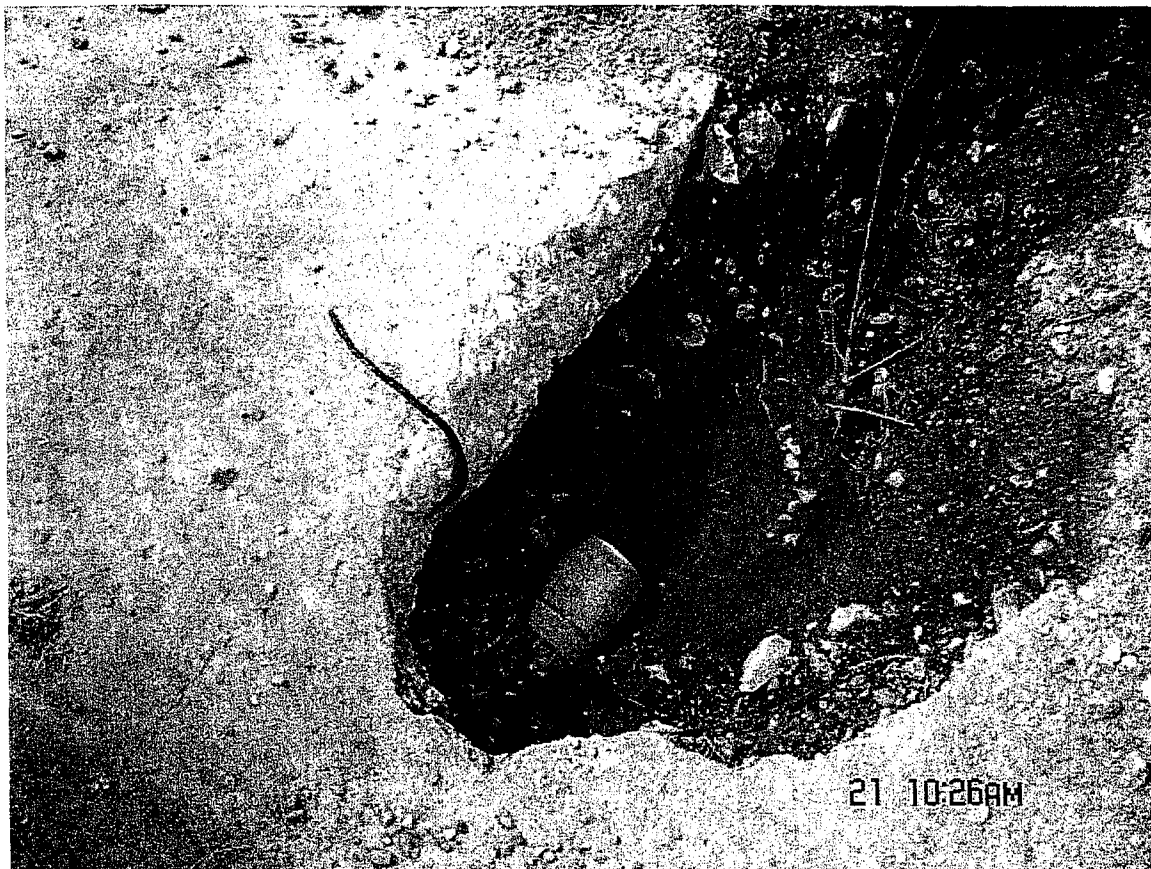
The pump room next to the old digester was investigated. New piping had been installed which appeared to better interconnect the east and west plants. There is more piping being installed. It was not clear where the new pipe was going. At least one segment was still not connected. The mystery pipe found on May 18, 2009, had mostly been removed. The section located under the drive next to the chlorine contact chamber was still there. (see pictures numbers 16, 17, 21, and 26)

26. This is what remains of the mystery pipe noted during the previous investigation. This is on the other side of the driveway from the chlorine contact chamber. The remaining pie runs back to the chlorine contact chamber. The date on this picture is incorrect. The actual date was August 20, 2009.

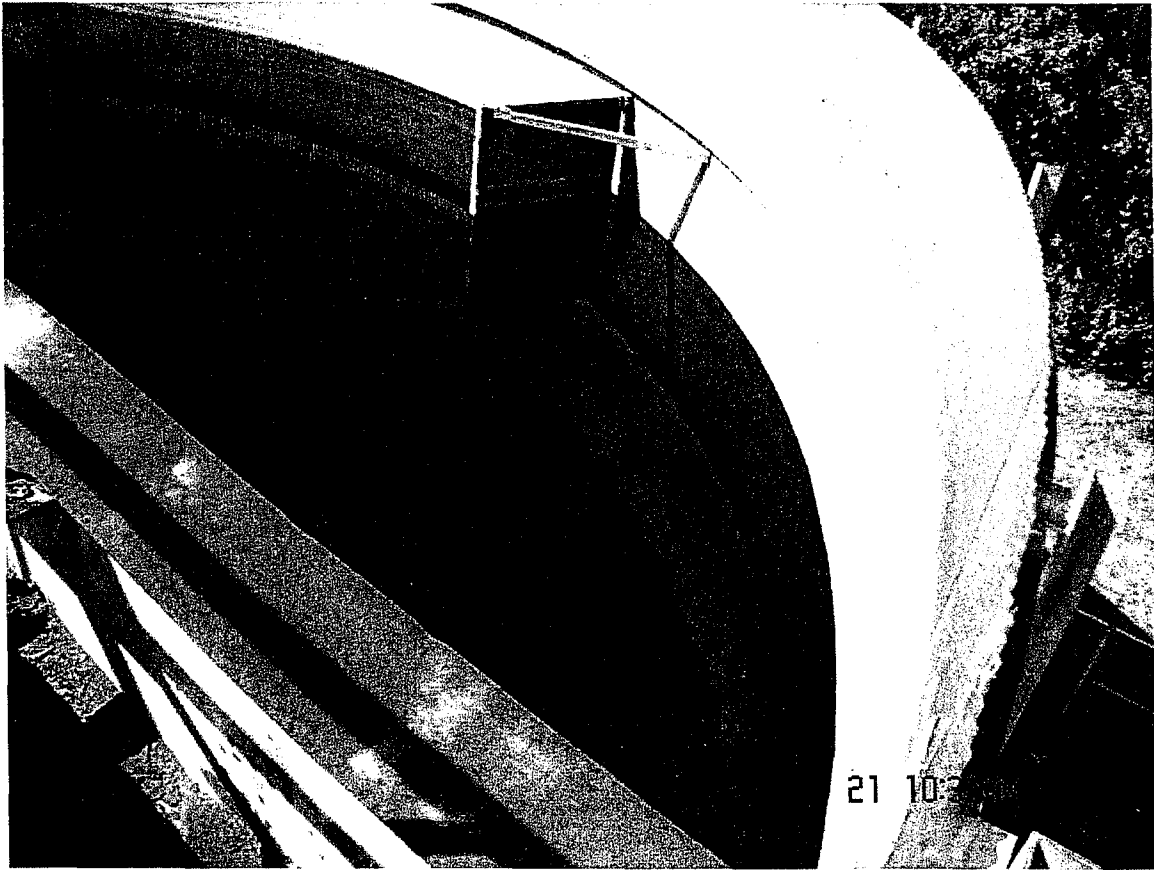
27. This picture shows black water in the old digester. The old digester is located in MCC Recycling east plant. The black water indicates the stored wastewater has gone septic. There were septic industrial wastewater odors at this vessel. The date on this picture is incorrect. The correct date is August 20, 2009.
